# Proposed At-grade Crossings of Officially Recognized Trails Port MacKenzie Rail Extension Project

#### 1.0 Introduction

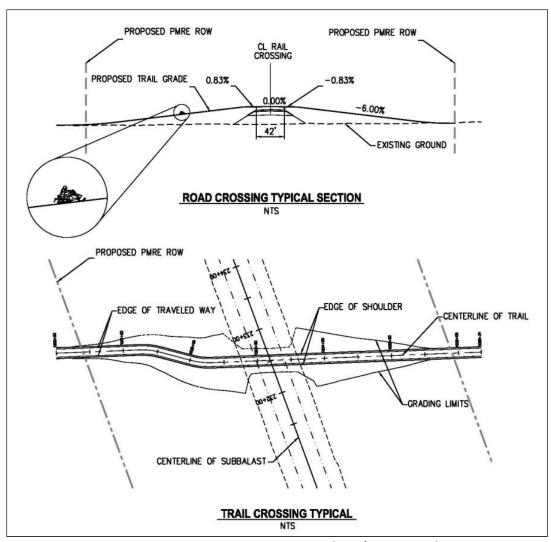
Exhibit 1: Typical at-grade crossing (trail/gravel road)

Big Lake Trail #1 is located in an existing Matanuska Electric Association (MEA) power line license on Knikatnu Corporation lands (Cook Inlet Regional Incorporated [CIRI] owns subsurface rights). An approximately 14-foot wide at-grade crossing with 20-foot crossing panels for the existing access road is planned at this location (refer to Exhibit 1 below). Grade separation is not feasible due to the relatively short distance to Millers Reach Road at-grade crossing and the need for the MEA power lines to cross.

ARRC and MSB (Project Team) has conveyed to trail users and agencies that this is a utility corridor and maintaining access may be challenging. Earlier in the process, the Project Team proposed relocating the trail to cross at the Millers Reach Road location, thereby leaving a gated crossing for MEA's use. The trails community disapproved with this solution due to the heavy use that the trail currently handles. The Project Team has since committed to an at-grade crossing for both trails and MEA use; however, the access will be gated if MEA or the property owner(s) chooses. Trails users will be required to work with MEA or the property owner(s) to ensure continued use and access. The Project Team proposes a reroute to Millers Reach Road in the event this trail access cannot be maintained at the current location. If access is allowed at this location, appropriate signage or signals will be placed on approaches to the crossing consistent with Mitigation Measure 60.

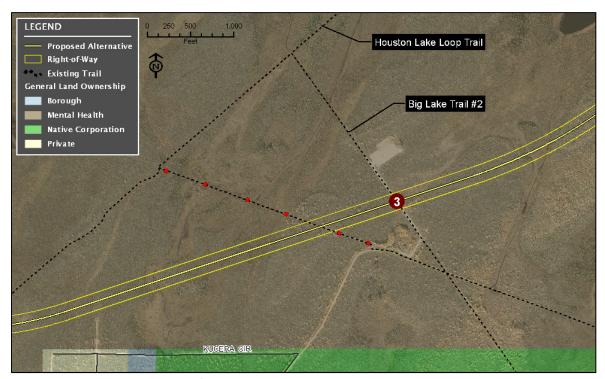
Exhibit 2: Aerial of existing developed gravel drive at Big Lake Trail #2.

Crossing 3 will include an approximately 32-foot wide at-grade crossing of an unnamed access road to a gravel pad that is currently leased from the Alaska Mental Health Lands Trust (MHLT). The Project Team is working with the MHLT to establish an easement for Big Lake Trail #2 at this existing crossing location; however, trails users will be required to work with easement/property owner(s) to ensure continued use and access. Grade separation is not practicable as the embankment footprint of the raised grade would substantially increase the wetlands fill and associated impact to the large wetland complexes in the area. Exhibit 1 represents a typical crossing for a trail or undeveloped roadway. Exhibit 2 illustrates the existing development at this crossing location. Appropriate signage or signals will be placed on approaches to the crossing consistent with Mitigation Measure 60.

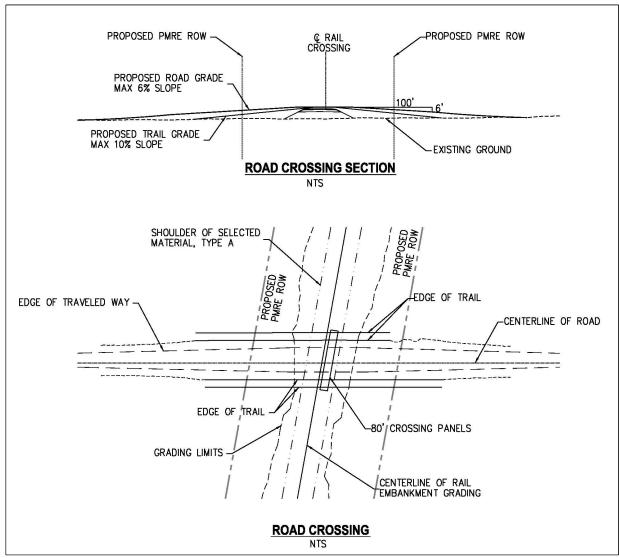
Exhibit 3: Typical at-grade road crossing (parallel trails)

The crossing of West Papoose Twins Road will be an at-grade crossing with signage or warning devices. This road is frequently used by trail vehicles as it is an extension of the Crooked Lake Trail and access across the tracks would be retained. Exhibit 3 below reflects the proposed at-grade crossing structure including trails both north and south of the roadway, and Exhibit 4 is an aerial view of the crossing location. Currently, trail users and vehicles share the existing road corridor; the Project Team has proposed to provide trails both north and south of West Papoose Twins Road to accommodate trail users. Appropriate signage or signals will be placed on approaches to the crossing consistent with Mitigation Measure 60

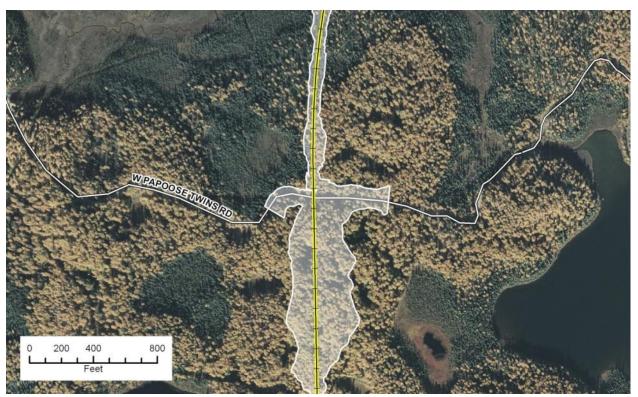
Exhibit 4: Aerial view of West Papoose Twins Road crossing location.
